# Shakey Lakes Integrated Management Plan

[ Lake Township, Menominee County, Michigan]

Prepared by:  
Lindsay Peterson, Conservation Projects Manager  
Wild Rivers Invasive Species Coalition  
420 N Hooper St.  
Kingsford, MI 49802

**December 2016**

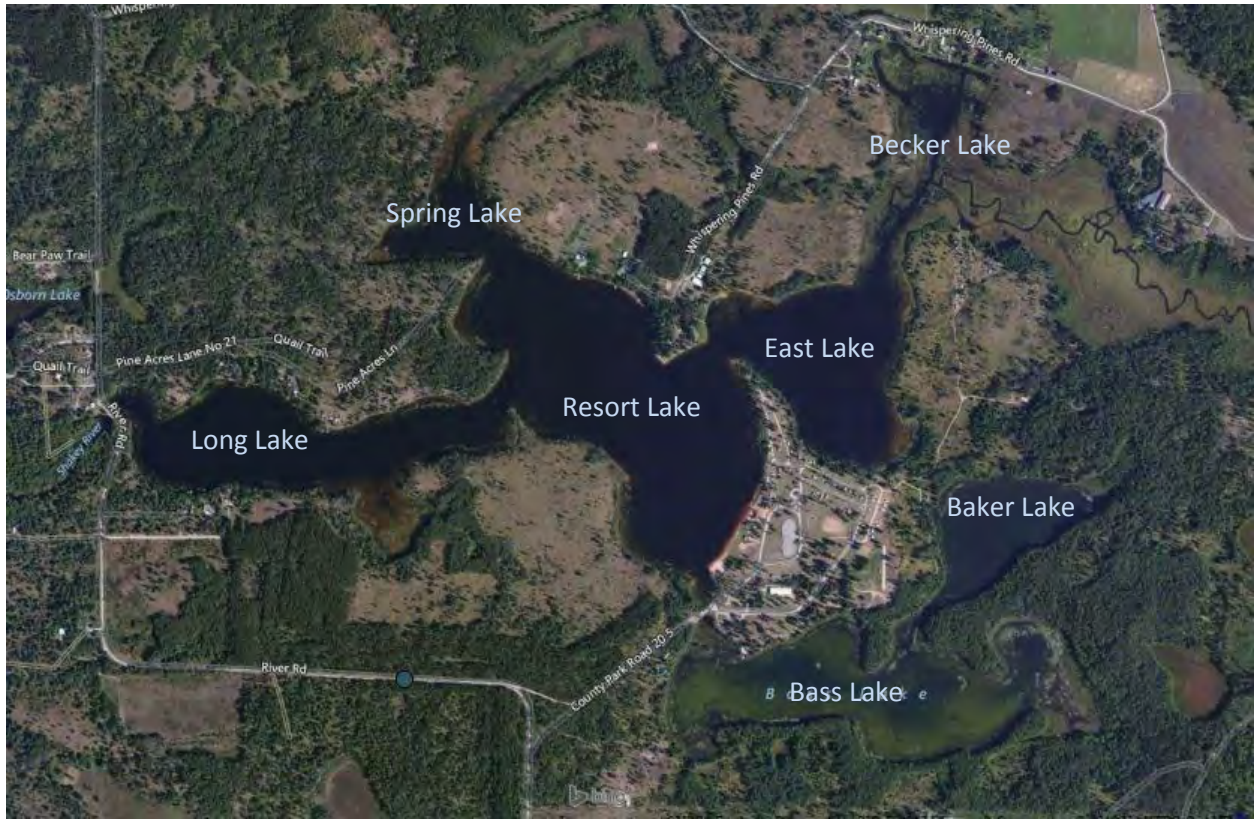
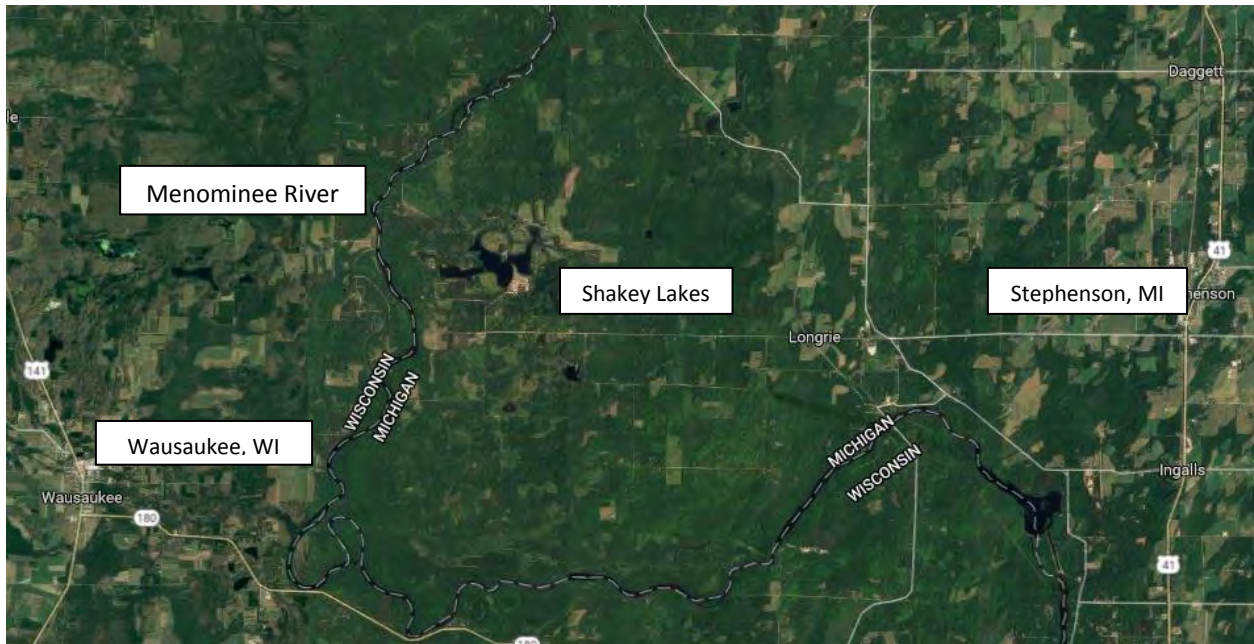
Figure 1. Satellite imagery of the various Shakey Lakes basins, and the lake's position in the surrounding area

Located in Menominee County, Shakey Lakes is approximately 12 miles west of Stephenson, Michigan. The Shakey Lakes chain is composed of 7 lakes including Bass and Baker, which are located on the south side of the park, Becker, Spring, Long, East, and the central basin known as Resort. They are the result of a man-made impoundment created from a dam located on the west end of Long Lake and is fed by the Shakey River, which enters the chain on the east end of Becker Lake. Once passing the dam, the Shakey River continues west and quickly connects with the Menominee River (Figures 1 and 2).

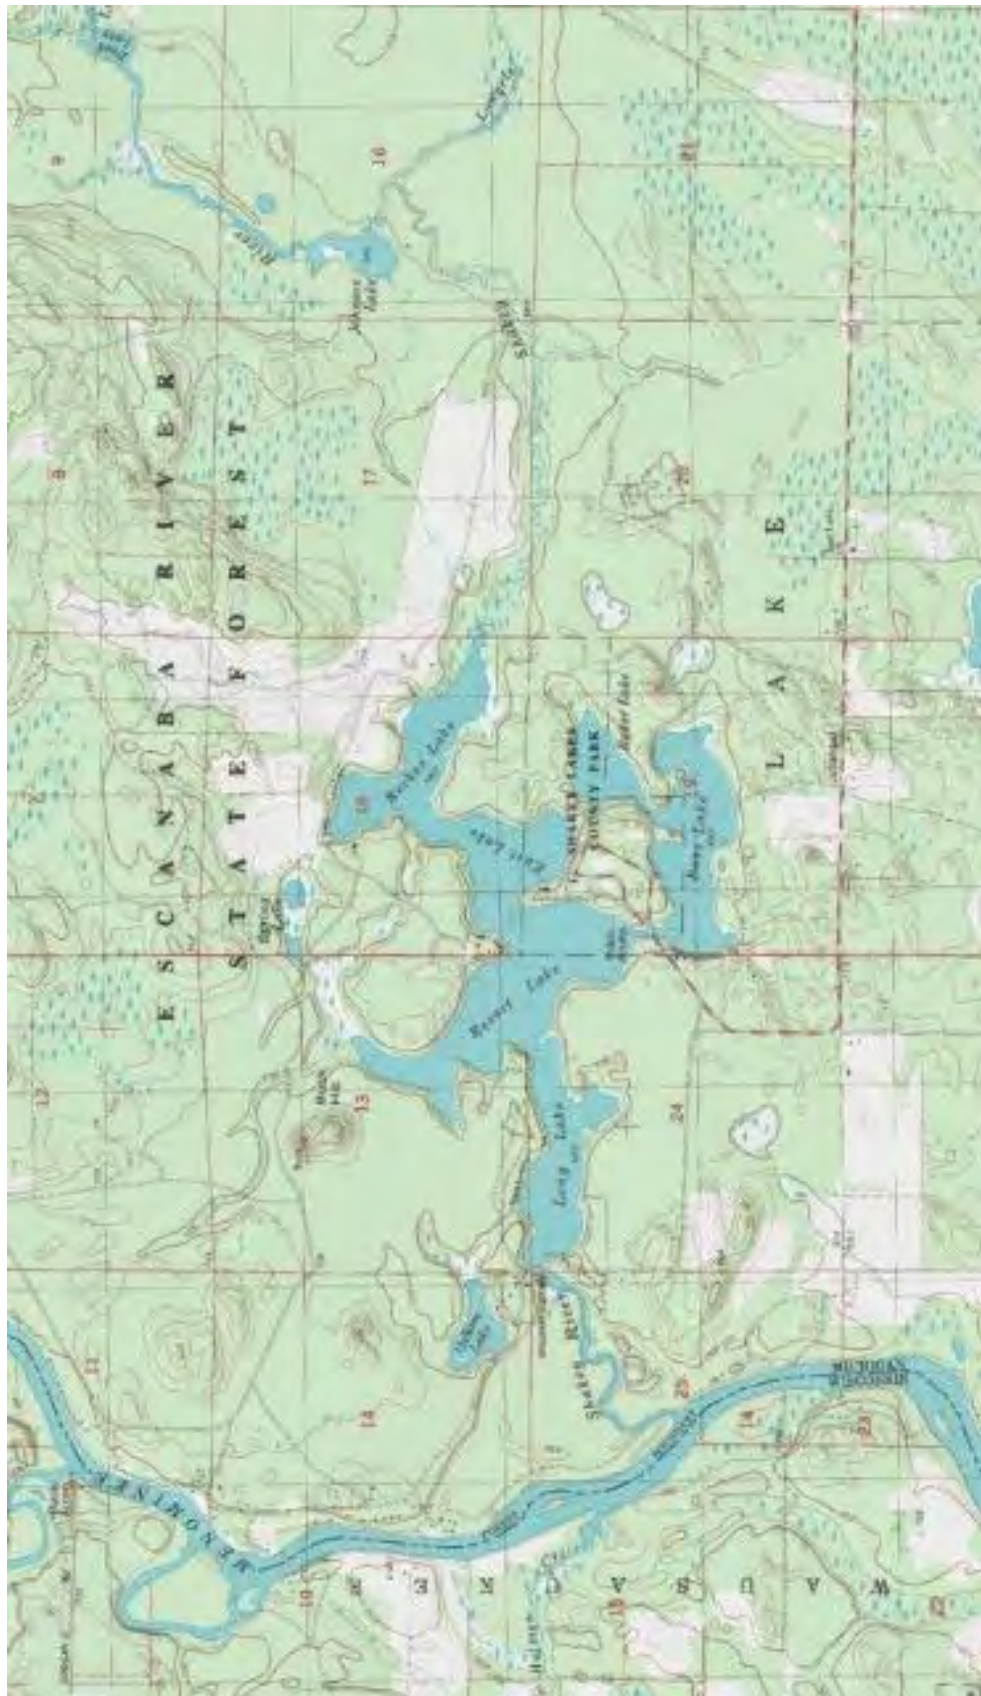
Figure 2. Topographic map of Shakey Lakes and the surrounding area

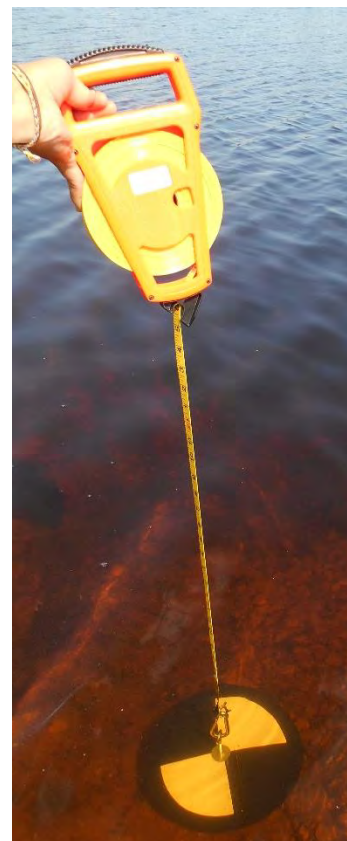
Figure 10. Secchi disk in stained water. (Peterson, 2015)

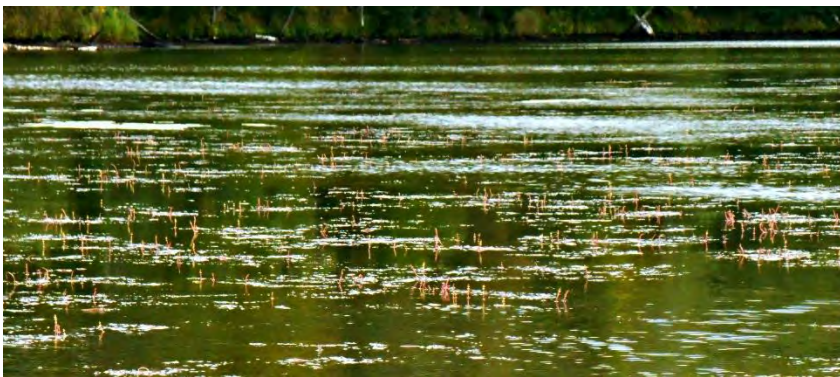
Figure 26 (left): Invasive milfoil flowers break the surface mid- to late summer.  
Figure 27 (right): Purple loosestrife is a common wetland or shoreline invasive.

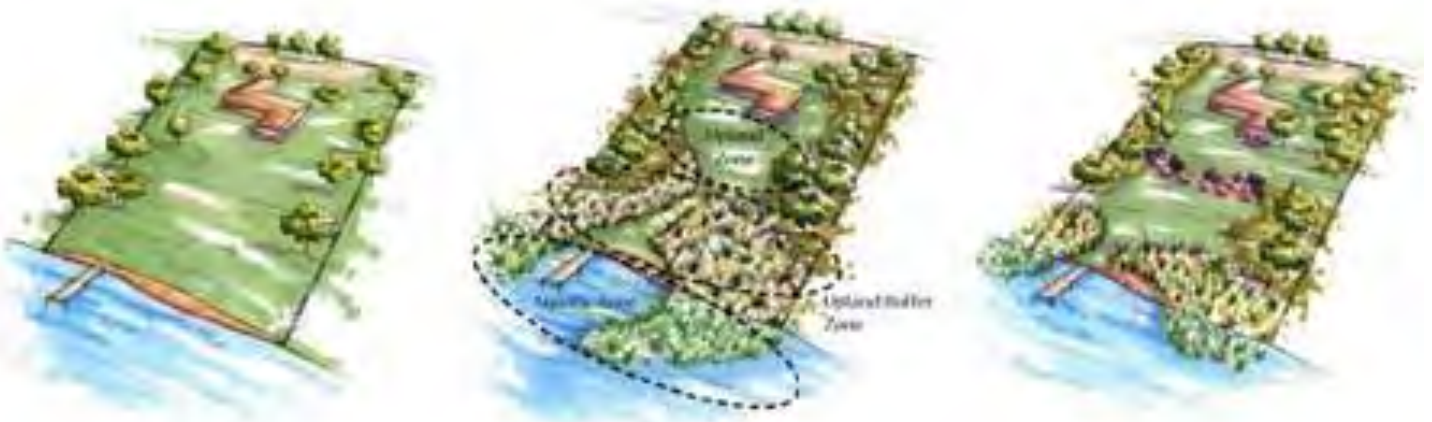
Figure 28. Left, traditional lake front landscape. Middle, residential lake front landscape with natural or restored buffer zones. Right, residential lake front landscape with manicured landscape with buffer zones. (Bricault, 2011)

Shoreline protection can be as simple as not fertilizing the lawn or not mowing right to the water, leaving what's called a "buffer" of vegetation, preventing erosion and filtering run-off. Restoration of an impaired shoreline could include the installation of native vegetation buffers or other erosion control structures that still provide habitat for animals and other aquatic organisms.

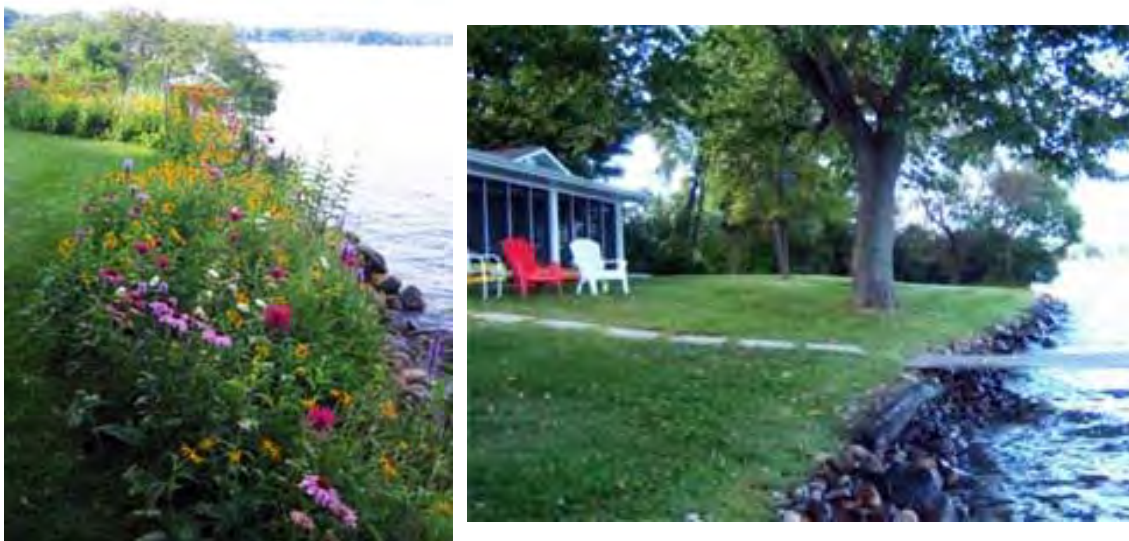
Figure 29. Example of shoreline buffer created with native vegetation, compared to a shoreline that lacks a buffer zone. (Bricault, 2011)

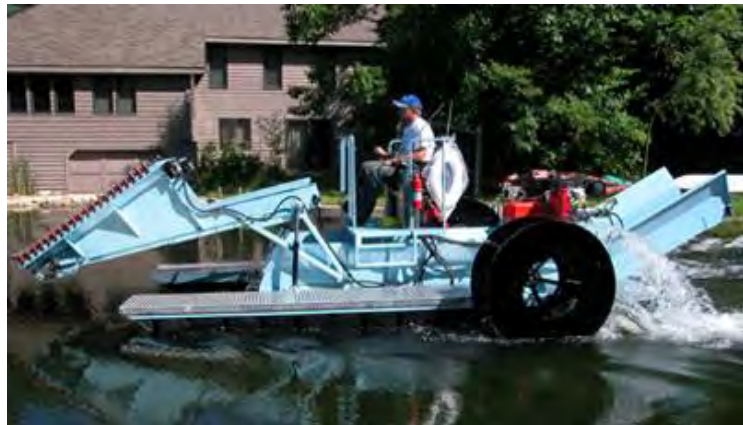
Figure 30. Example of mechanical weed harvester ([www.inlandlakeharvester.com](http://www.inlandlakeharvester.com), 2016)

Mechanical control methods involve the use of tools or equipment to remove nuisance plants and are quite varied. Several methods typically involve cutting up aquatic plants using the equipment. Some techniques involve the collection of plant material during this process, therefore it is sometimes referred to as mechanical harvesting. However, not all methods collect the plant material and

sometimes leave it in the lake for disposal, usually after shredding or grinding. Methods such as rotovating do not focus on cutting plant material but rather on impacting substrates, in this case with a long-armed cultivator and preventing the establishment of rooted vegetation in these areas. Weed rolling is also used to compact sediments to prevent plant growth as well.

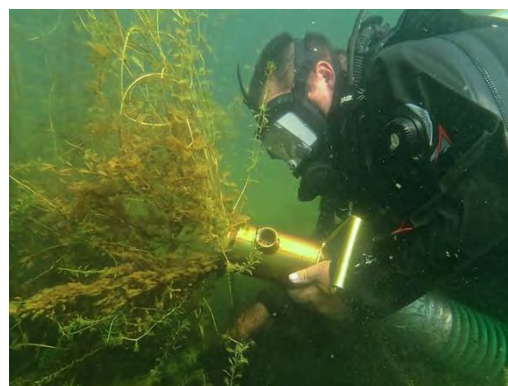
Figure 31. Diver uses suction harvesting to remove invasive milfoil in Marinette Co. (Hennelly, S., WI Land and Water, 2016)

Also included in this category are hand cutting/pulling and diver assisted suction harvesting, or DASH. Hand pulling involves removing the entire plant, including roots, by hand. This method is low impact, selective of native species, and if done carefully can be useful to control small, localized infestations. Similarly, hand cutting is done on small populations of target plants but is more likely to cause fragmentation of plant parts as compared to skillful hand-pulling. For deeper waters or somewhat larger infestations of nuisance plants, DASH may be utilized. In this method a diver uses their hands to remove the plant and the root but instead of having to resurface to dispose of the plants, plant material is fed into a vacuum hose and transported to a boat on the surface. At the surface, plants are collected in bins or bags which allow water to filter out but retains all of the plant material, reducing fragmentation and risk of spread. However this method is still time consuming and demanding for the diver, so is best used with small or pioneering populations in moderate depths.

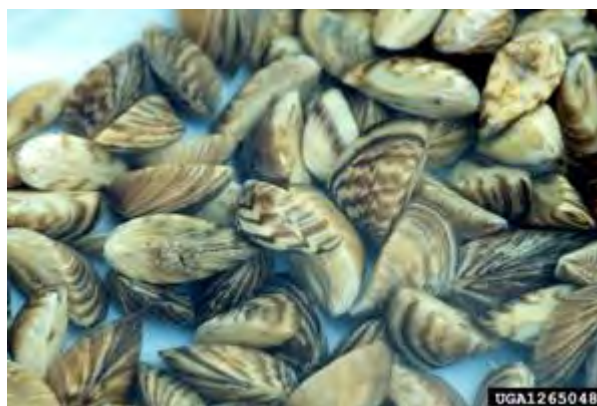
Figure 37. Zebra mussels. (Benson et al, 2017)

Zebra mussels are another long-standing threat to lakes in this region. Zebra mussels (*Dreissena polymorpha*) are native to the Black and Caspian Seas and are believed to have been introduced to the Great Lakes through shipping and ballast water, eventually migrating inland to lakes and rivers, their spread often being augmented by human activity, especially recreation. Zebra mussels tend to be quite small (< 50mm) and are actually microscopic during their larval stages of development, where they're known as veligers, making it difficult to prevent spreading them. They mature much quicker than native mussels (within about 1 year) and reproduce rapidly since over 40,000 eggs can be laid in a reproductive cycle and up to one million in a spawning season. As the veligers settle to the bottom of the lake, they seek out and attach themselves to suitable substrates using their byssal threads. Zebra mussels tend to prefer hard surfaces, such as rocks, docks, or even native mussels, but are known to attach to vegetation as well (Benson et al., 2017).

Zebra mussels can have profound effects on the ecosystems they invade. They primarily consume phytoplankton, but other suspended material is filtered from the water column including bacteria, protozoans, other zooplankton, and silt. For example, increase water clarity caused by zebra mussel filtration can allow aquatic plant communities to grow more and even colonize new areas that were not suitable before. Zebra mussels also impact fisheries by consuming phyto- and zooplankton, which are food sources for juvenile fish. The selective feeding strategies of the zebra mussels can also result in toxic algae blooms as they consume most other algae but reject those that may be toxic, allowing that algae to thrive in the absence of competition.

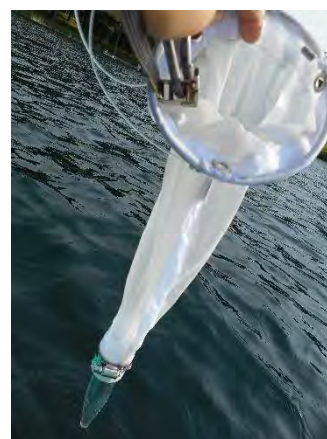
Figure 38. Plankton Tow with sample collection vial attached. (Peterson, 2016)

Follow-up was carried out and included re-sampling for eDNA, several plankton tow samples, and a meander survey of the shoreline and docks. A plankton tow is a fine mesh net with a ring opening on one end and tapering off to a point where a sample bottle can be attached (Figure 38). This device is lowered into the water vertically or towed behind a boat horizontally to sample for microscopic organisms in the water column, including veligers, the larval stage of zebra mussels. Several vertical tows were done on Shakey Lakes late in the season of 2015 but no veligers were discovered in the samples.

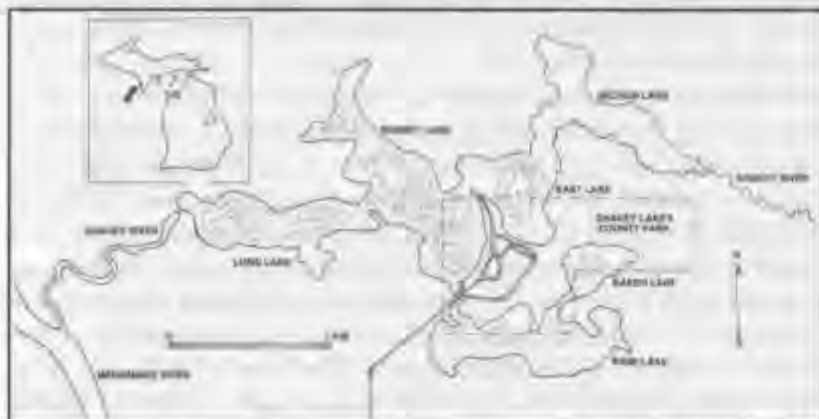
Figure 1 — Map of the Shakey Lakes system. Drawn by D.A. Burton from a USGS topographic map with 10 foot contours (dotted lines) drawn by eye from the Institute of Fisheries maps of the lakes available from the Michigan United Conservation Clubs.

The Shakey Lakes system consists of five lakes located in the southwestern part of Menominee County in the Upper Peninsula of Michigan a few miles inland from the mouth of Green Bay near the Wisconsin border (Figure 1). The interconnected lakes making up the system are Bass and Baker (92 acres), Becker (8 acres), East (70 acres), Resort (100 acres) and Long (80 acres) Lakes. The depths of these lakes

range from 8 feet to 43 feet with all of Becker, most of Bass and Baker, and a substantial part of East Lake being less than 10 feet deep (Figure 1). Depths of less than 10 feet, water of reasonable clarity (Secchi depths usually exceed 10 feet), and nutrients brought in by the Shakey River make growth of rooted aquatic plants in these areas of Shakey Lake almost a certainty. In fact, the 1942 map of the lake by the Institute of Fisheries Research showed that most of the shallow areas supported weed growth at that time. The deeper, central portions of Resort and Long Lakes have minimal weed problems. Riparian owners around Becker Lake, in particular, have difficulty keeping access to the rest of the lake system because of the aquatic weed problem. Bass and Baker Lakes are separate lakes, although they are connected to Resort Lake by a culvert, while the other four "lakes" are all a part of a single lake system on the Shakey River, a tributary of the Menominee River. The Shakey River enters the shallow Becker Lake and exits from Long Lake at an outlet structure that controls water level in the system.

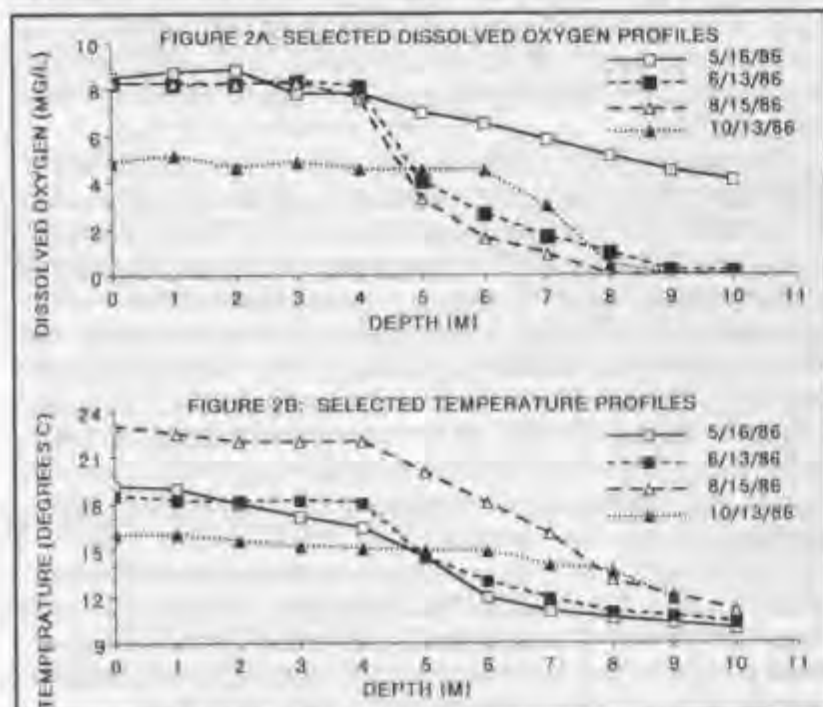
Figure 2 — Selected dissolved oxygen and temperature profiles for Resort Lake in 1986.

A substantial drop in dissolved oxygen in Shakey Lakes occurred between September 10 and October 3, 1986, from normal summer readings of 8-9 mg/L in the top 4m of the
